ICE Handbook of
Concrete Durability

A practical guide to the design
of resilient concrete structures

Second edition

Edited by Marios Soutsos

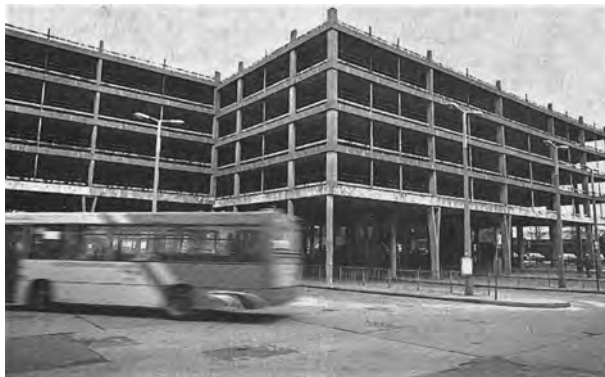
Figure 1.1 Multistorey car park in Colchester that was pulled down in 1995 because concrete corrosion problems were beyond economic repair

A multistorey car park in Colchester was pulled down in 1995 because concrete corrosion problems were beyond economic repair (Figure 1.1) [3].

The Queen Street car park was put up only in 1971 under a design and build contract by the now defunct contractor Shears-Neal. By 1985, evidence of corrosion in precast concrete units on the in situ concrete frame prompted Colchester Borough Council to commission consultant Eastwood & Partners to report on the structure. Eastwood found that 3% of units were affected and made repair recommendations to prolong its life by 5 years. In 1992, the car park, which sits over a live bus station, was closed for safety reasons. Eastwood reported that 40% of the units were then affected. Refurbishment costs were put at £1.5 million, rebuild at £3 million and demolition at £350,000. The council opted for demolition.

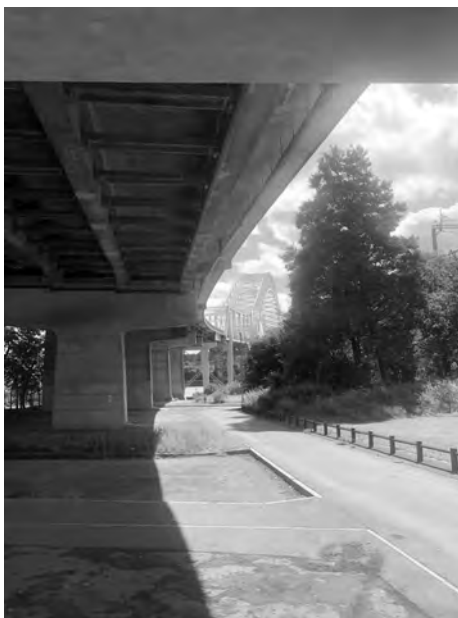
Figure 1.2 Concrete approaches to the Runcorn Bridge

Problems on the 34-year-old 27-span crossing with its striking 330-m central lattice steel arch were first identified in 1989 [4]. The three-span bridge itself, with its concrete deck, was in reasonably good condition, thanks to owner Cheshire County Council's £1 million a year maintenance programme. However, all the concrete approaches were in a less favourable state (Figure 1.2). Each is made up of four in situ longitudinal deck beams carried generally on a single central pier with an integral cross head. The ever familiar story of road salt seeping down through leaking deck expansion joints to attack beams, cross heads and piers was all too evident on both sides of the Mersey.

The worst damage was beneath the Widnes approaches, which were widened in 1977 by adding a separately supported 5-m-wide strip of deck. Here the main culprit was a 500-mm-wide longitudinal infill slab that connected the original and extended sections of the deck.

Flexible joints supporting both sides of the infill were leaking, allowing chloride-rich surface water to run down. Chloride levels in the rectangular beam, which is up to 2 m deep, approached 2% by weight of cement. The concrete had spalled and delaminated and the link steel had been attacked. However, the four layers of the main densely packed 50-mm rebar were relatively unscathed.

Cathodic protection was installed in the chloride-riddled approach spans, which avoided the widespread demolition and reconstruction of the damaged spans for one of the River Mersey's most strategic crossings. Importantly, this was the first full-scale application of a micro-concrete gunite overlay, which claimed to solve the historic package of problems surrounding such specialised sprayed-concrete applications.

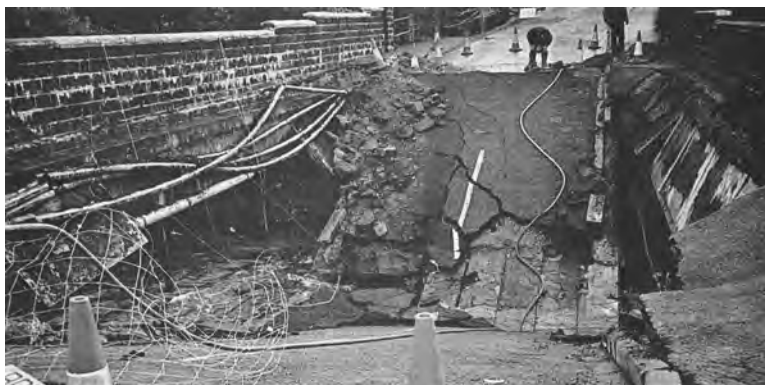
Figure 1.4 The collapse of the Ynys-y-Gwas Bridge led to a ban on grouted tendons [6]

Bridge owners have for many years been concerned about the corrosion of prestressing cables and the difficulty of inspection. These concerns were highlighted in December 1985 with the sudden collapse of a 32-year-old 18.3-m-span post-tensioned segmental road bridge in South Wales (Figure 1.4) [6]. The failure of the Ynys-y-Gwas Bridge was directly caused by tendons corroded by chlorides from de-icing salts. The salt penetration was eventually attributed to a combination of inadequate tendon protection, poor workmanship and ineffective deck waterproofing. Other key factors identified included the lack of an in situ top slab and joints opening under load.

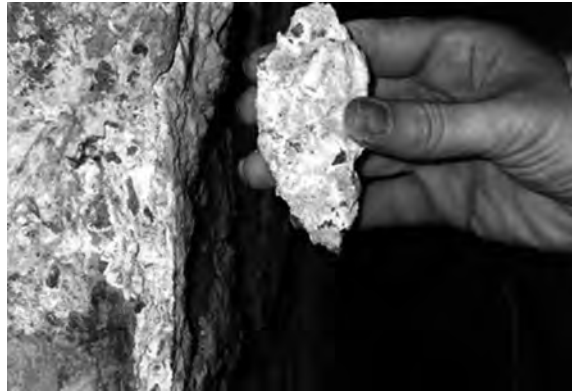
Figure 1.5 Thaumasia attack against a bridge in Gloucestershire

The research was a clear indication of the government's increasing fears over the possible scale of the problem. The Highways Agency revealed ten cases of thaumasite on bridges on the M5 in Gloucestershire (Figure 1.5). A further 27 structures were understood to have been identified as vulnerable to thaumasite attack on country roads in Gloucestershire.

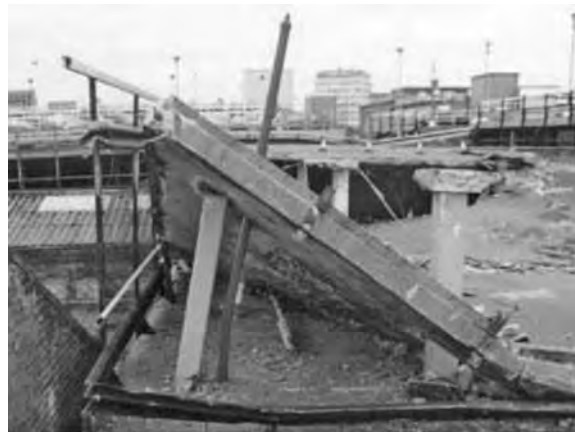
Figure 1.6 Collapse of Pipers Row multistorey car park in Wolverhampton [18]

The Health & Safety Executive published its report into the 1997 collapse of the Pipers Row multistorey car park in Wolverhampton in 2004 (Figure 1.6) [18,19]. The research identified that lift slabs were susceptible to punching shear if the concrete had deteriorated in the slab/column zone.

Pipers Row was a punching shear failure and occurred when there was only a dead load, implying that there had been an apparent major reduction in strength. The failure was initiated by local deterioration of the concrete, confirmed both by examination of the debris and by subsequent rigorous structural analysis. The concrete in the collapsed top slab was of lower quality than elsewhere in the structure. It had been exposed to the elements for over 30 years and undoubtedly went through many freeze–thaw cycles. Frost action

led to the concrete becoming friable all the way into the slab near an internal column and as far as the top steel, eventually leading to a complete loss of bond and anchorage. Rigorous analysis of Pipers Row clearly showed that the undeteriorated as-built strength had a safety margin of at least 1.5 against the worst possible in-service load.

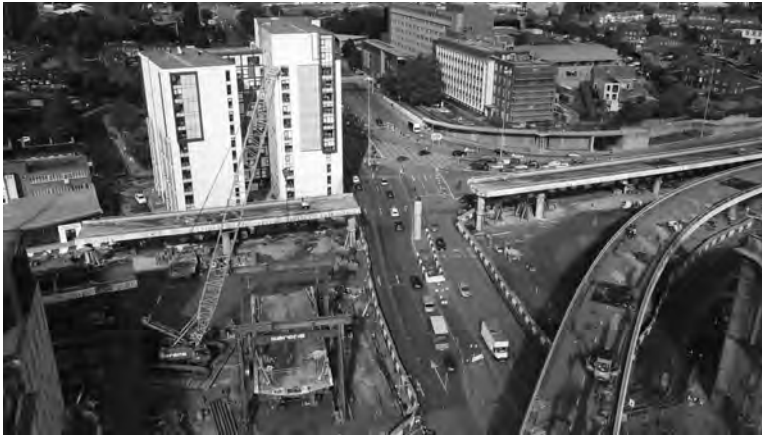
Figure 1.8 Removal of Liverpool's condemned Churchill Way flyovers [22]

Demolition was a complex job since the flyovers were multi-span post-tensioned concrete girders (Figure 1.8). Taking down one part of any structure could have caused damage elsewhere. The concrete girders were cut in situ, lowered to the ground using heavy-lifting equipment and then cut into smaller sections and transported off site. This was to minimise the dust, noise, vibration and environmental impact to the surrounding area.

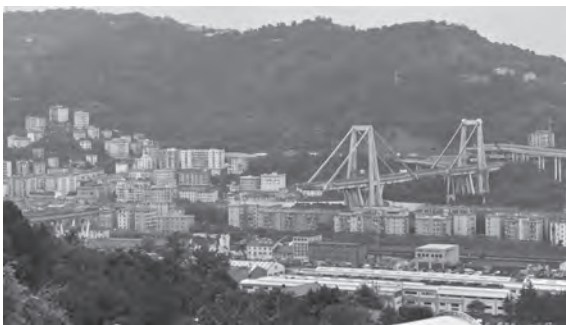
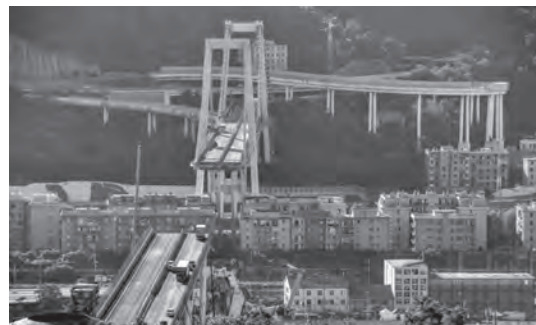
Figure 1.9 Collapse of the Morandi Bridge in Genoa in 2018 [25]

A 250-m-long deck section of the Polcevera Viaduct, more familiarly known as Genoa's Morandi Bridge, collapsed on 14 August 2018 killing 43 people (Figure 1.9) [24]. The viaduct was 1.1 km long and had three 90-m-tall towers. One of the three towers collapsed. The foundations of the tower were being strengthened
